# Manhole Inspection Summary

Manhole # S31YY1010MH

Insp Date: **1/23/07 10:18 AM**

**Location** Address: **103 WITHERSPOON RD**

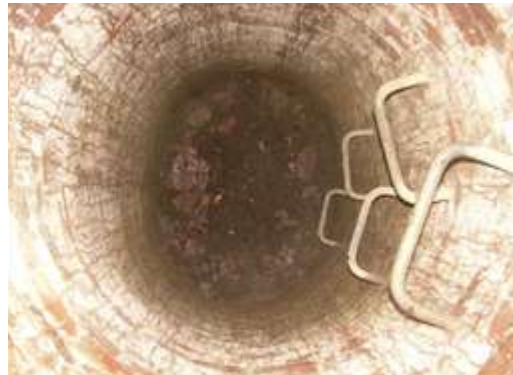
Top View

Channel debris.

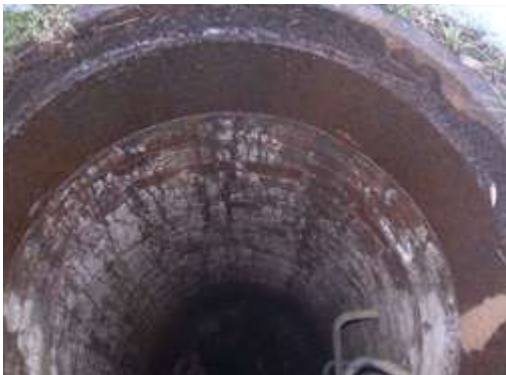
Defect

☒ **Leaks**

Infiltration: ☐ None ☒ **Joint** ☐ Cracks ☐ Mortar ☐ Roots ☒ **Wall**

Frame leaks. Adjustment infiltration.

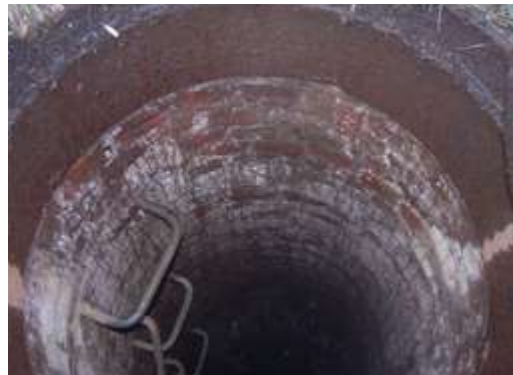
Defect

Frame leaks. Adjustment infiltration.

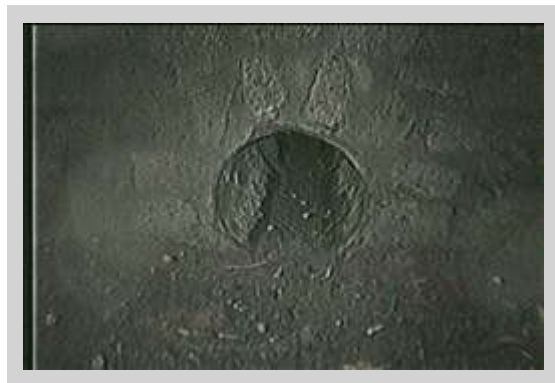
Pipe Out @ 12 O'Clock

Deposits: ☐ None ☒ **Mud** ☐ Sludge ☒ **Debris** ☐ Grease

Silt Depth: **0.5** (in.)

Deposits Extent: **Light**

Infiltration: **Evidence**
